Effect of Direct Lightning Strike in the Down Conductors Embedded into the Reinforcement

D. Kokkinos, N. Kokkinos, J. Koutsoubis, M. Klabana, Ath. Triantafyllides, *ELEMKO SA*,
Ch. Charalambous, *University of Manchester*

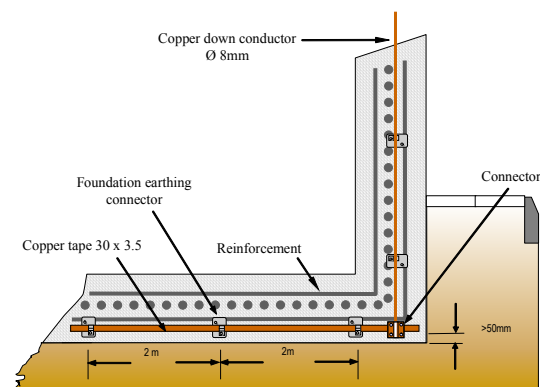
Fig. 1: Foundation earthing and down conductors bonded with the reinforcement

As described in IEC/EN 62305 – 3 [4], [5] the down conductors may be bonded with the reinforcement. Figure 1 represents part of the foundation earthing and the down conductor driven through the reinforced concrete of a structure. As shown in Figure 1 specific connectors are used to bond the LPS conductors with the reinforcement bars. Figure 2 and 3 show appropriate connectors that fulfill the requirements of EN 50164 – 1 [6] and provide an approved electrical and mechanical connection between the LPS conductors and the reinforcement bars.

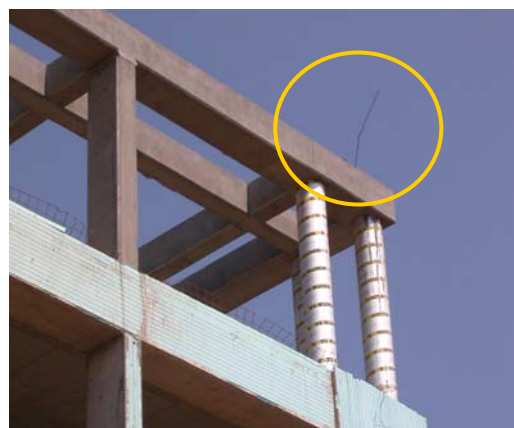
Fig 2: Down conductor installed through the reinforcement

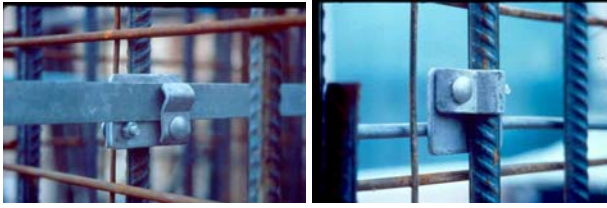
Fig. 3: Approved connectors for connecting LPS conductors with the reinforcement

As shown in Figure 6, specimen A was with the appropriate connector, which is similar to the one described in Figure 3, the tightening torque was set at 12Nm for both screws. Specimen B was with wire but the wire was very tight around the LPS tape and the reinforcement bar. In specimens C and D the wire was not so tight, which was allowing a small void to be formed between the LPS tape and the steel bar. In specimen C was 1mm and in specimen D was 10mm. The contact resistance in all the specimens was less than 1mOhm.

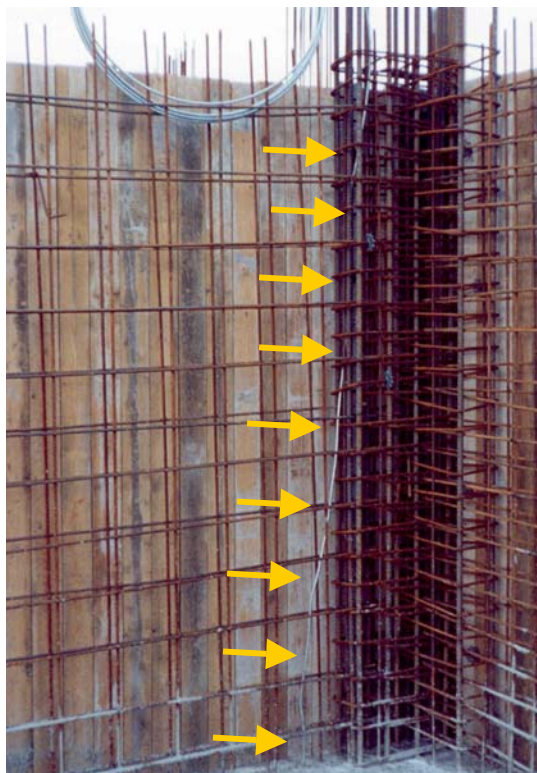
Fig. 4: Down conductor is driven through the reinforcement without having any bonding with it.

In contrast Figure 4 and 5 shows a non approved connection between the LPS conductors and the reinforcement bars. Many believe that the reinforcement may also be used as an extension of the LPS conductors and they don't use down conductors to connect the air terminals with the earthing system but only the reinforcement bars. However the reinforcement bars may have voids between them, which will generate an arc causing serious cracks in the concrete.

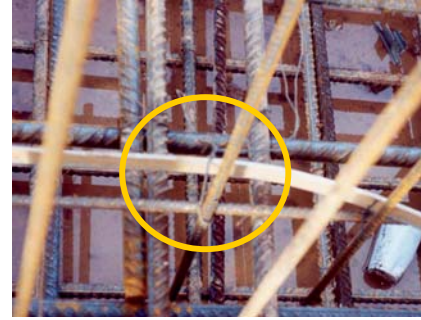
Fig. 5: Non approved connection between earthing tape and reinforcement

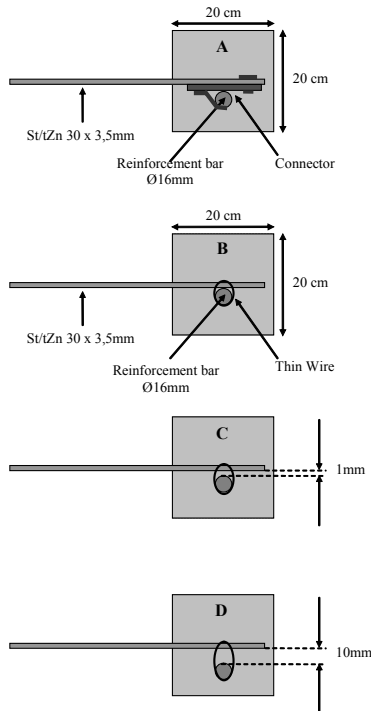
Fig. 6: Preliminary test specimens – top view

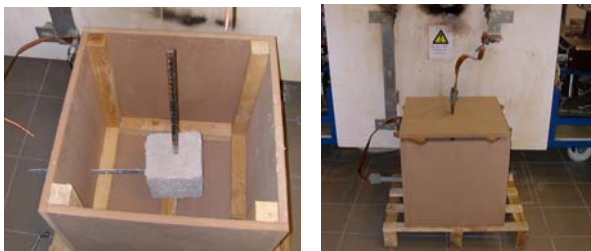
Fig. 7: Experimental set-up of the preliminary tests

For safety issues the specimens were sealed in a wooden box. The two terminals of each specimen were then connected to the output of the 100kA, 10/350 μs generator as shown in Figure 7.

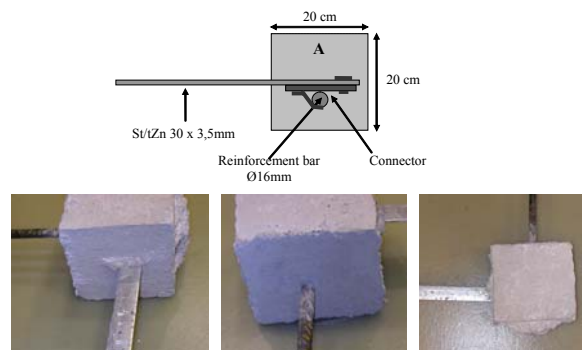
Fig. 8: Results after five lightning impulses for specimen A

Specimen A was tested first, which had an appropriate connector to provide an electrical and mechanical connection between the LPS tape and the reinforcement bar. Table 1 summarizes the results, which have proven that specimen A has successfully discharged five lightning impulses with a 10/350 μs up to 98kA without causing any visual damage to the concrete surface.

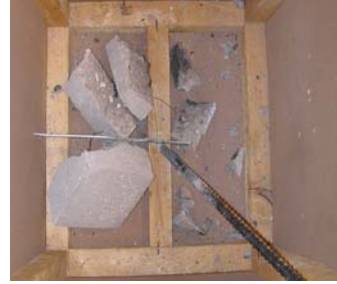
Fig 11: Results after one lightning impulses for specimen D

Specimen D was tested last, which had a very loose wire to provide an electrical and mechanical connection between the LPS tape and the reinforcement bar. Table 4 summarizes the results, which have proven that specimen D could not discharge any lightning impulses since the concrete was broken with the first impulse at 35kA, 10/350 μ s.

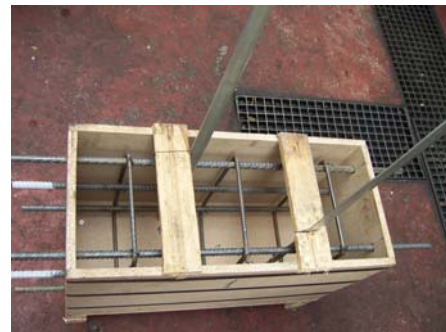
Fig 12: Reinforcement block with various connections

The reinforcement block is shown in Figures 12 and 13. It was composed out of six horizontal reinforcement bars having a diameter of 16mm bonded with each other by using three reinforcement bonding rings with diameter of 10mm. At every cross point between two reinforcement bars there was a tight wire bond. Two LPS conductors (hot deep galvanized steel tape 30 x 3,5mm) were connected in either side of the block as shown in the Figure 12 and 13. One was bonded with the reinforcement with the same connector as in the preliminary tests in specimen A and the other was bonded with the reinforcement only with one tight wire (see Figure 14).

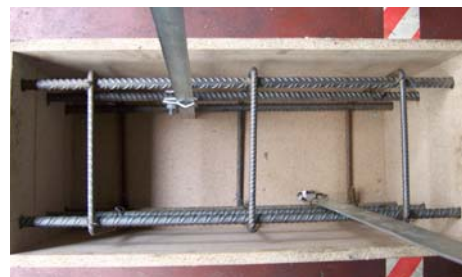
Fig 13: Reinforcement block with various connections – top view

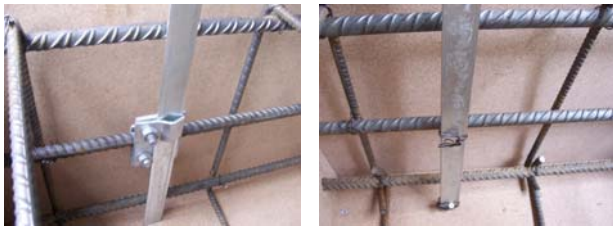
Fig 14: Detail of connections between the LPS conductors and the reinforced bars on both sides of the specimen

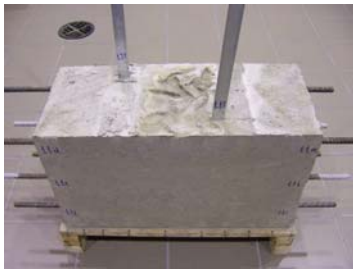
Fig 15: Reinforced concrete block with various connections

The reinforcement block was then embedded in concrete having the same quality as in the preliminary tests. Figure 15 shows the reinforced concrete block, which had the following dimensions: Length 80cm, height 60cm, width 30cm.

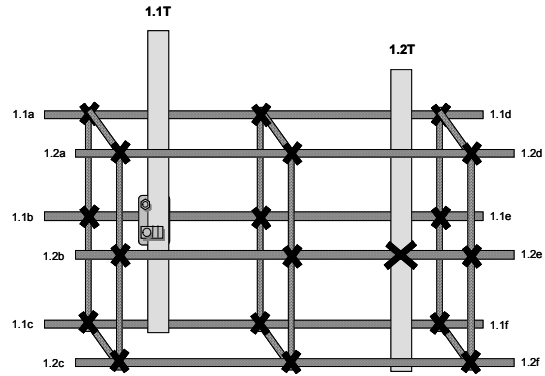
Fig 16: Numbering of reinforcement bars and LPS conductors for identification during the testing procedures

The generator output was connected on various configurations as summarized in Table 5. Figure 16 shows the numbering, which was given on each reinforced bar and LPS conductor for identification purposes.

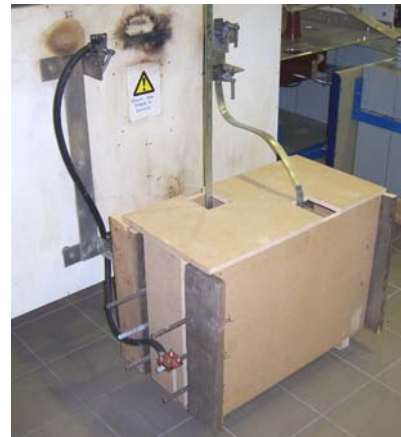
Fig 17: Experimental set-up of the final tests

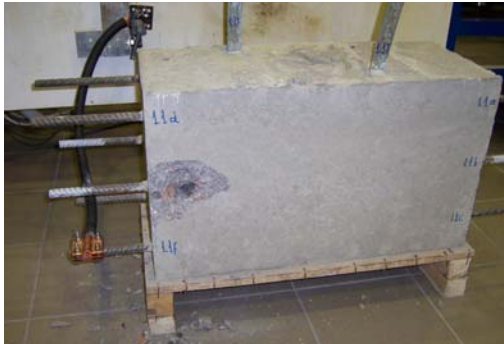
Fig 18: Results after two lightning impulses between 1.1T and 1.1e

- (1) Concrete block did not show any visual damage or cracks
- (2) After the second impulse at 63.6kA the block presented cracks and serious damage on the 1.1e point – Figure 18
- (3) After the second impulse at 63.6kA the block presented cracks and serious damage on the 1.1b, 1.1c and 1.2c – Figure 19
- (4) After the second impulse at 59.2kA the block presented cracks and serious damage on the 1.2d, 1.2e and 1.2f – Figure 20 and 21

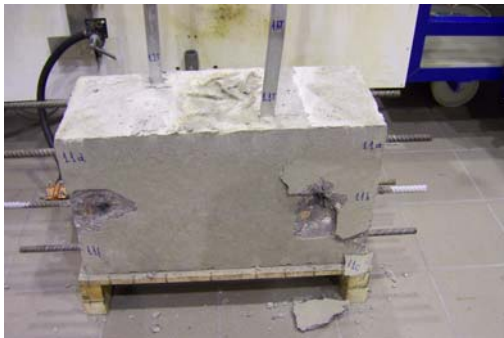
Fig 19: Results after two lightning impulses between 1.1T and 1.2c

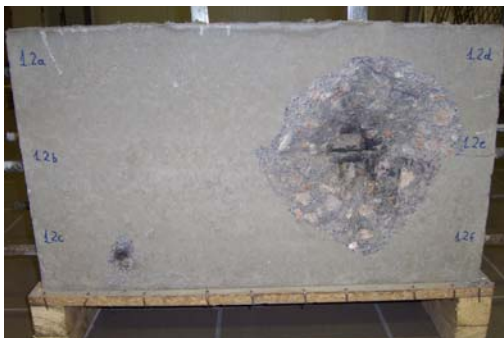
Fig 20: Results after two lightning impulses between 1.1T and 1.2T

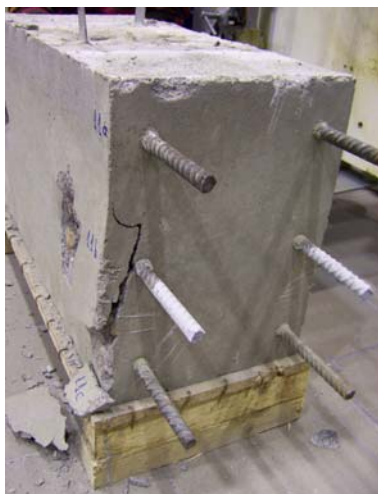
Fig 21: Results after two lightning impulses between 1.1T and 1.2T
